Case Report

Misplaced cochlear implant into the superior semicircular canal

Department of ENT, Unidade Local de Saude de Santo António, Porto, Portugal

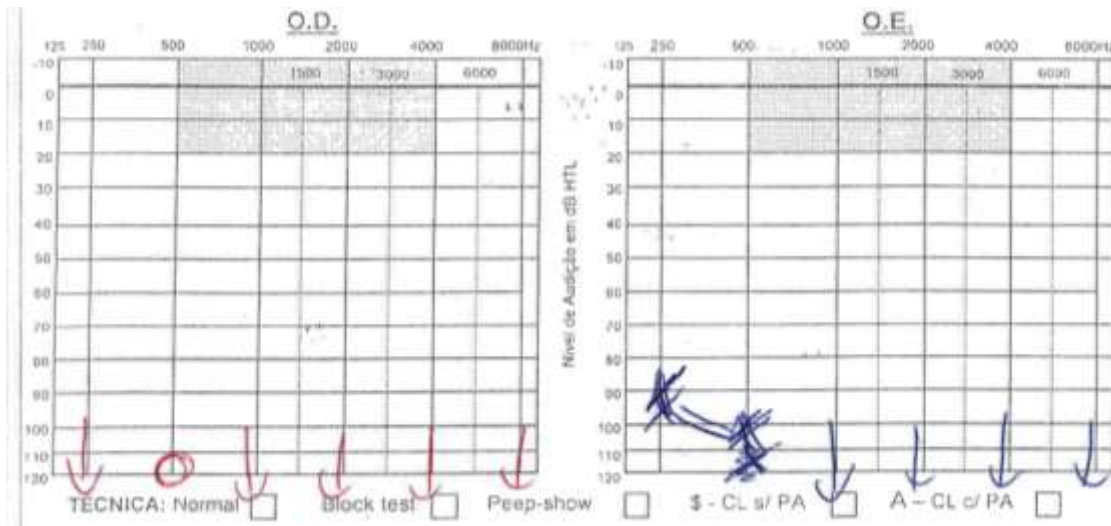
Figure 1: Audiogram showing a profound bilateral sensorineural hearing loss.

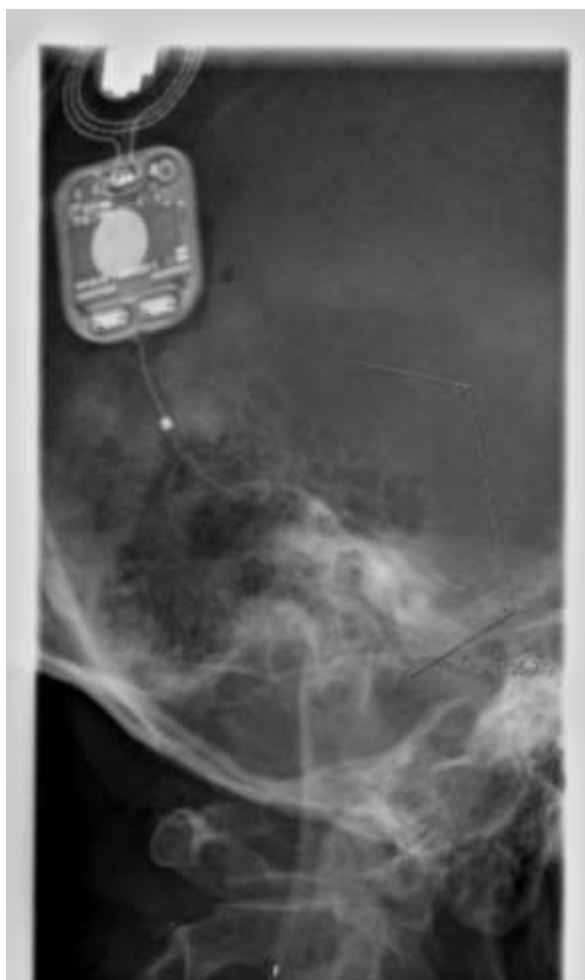
round window was clearly identified and electrode array was fully inserted through the membrane with no resistance. NRT was performed and no neural response was detected. On the next day a cranial x-ray was performed and already showed an abnormal electrode array position (Figure 3). A CT-scan showed placement of electrodes on anterior aspect of the vestibule and in superior semicircular canal (Figure 4 to 6). Patient hadn't vestibular symptoms due to already known left vestibular

Figure 3: Cranial x-ray showing an abnormal electrode array position.

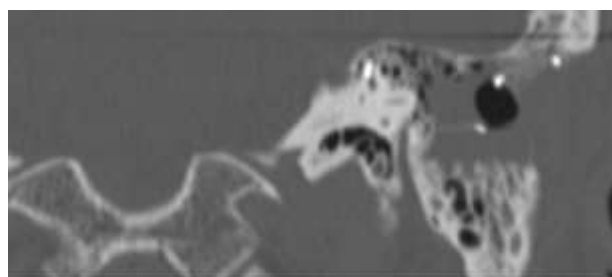
Figure 6: Coronal CT-scan showing placement of electrodes in superior semicircular canal.

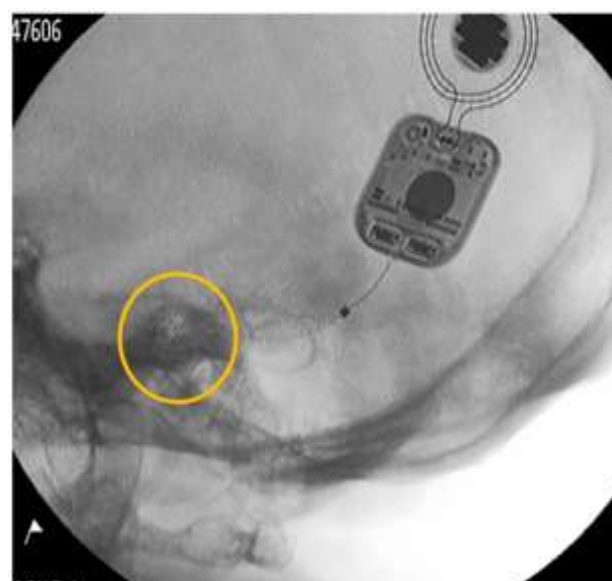
Figure 7: Cranial x-ray showing a normal electrode array position.

hypofunction. It was performed a surgical revision where the misplaced electrodes were removed and reimplantation through round window was performed. Electrode position was confirmed by taking an intraoperative cranial x-ray (Figure 7). One month after surgery CI was activated without any complication. Patient had an improvement in hearing thresholds (pure tone average approximately 50 dB) (Figure 8).
